Improving the seismic resistance of cultural heritage buildings

P.B. Lourenço, D.V. Oliveira, G. Vasconcelos, L.F. Ramos

ABSTRACT: The paper addresses a possible methodology to improve the seismic resistance of cultural heritage buildings (CHB). The ICOMOS recommendations are briefly reviewed and recent research issues are addressed, with a focus on: (a) Behavior of masonry components under cyclic loading (tension, compression and shear); (b) Behavior of stone masonry shear walls under cyclic and dynamic loading; (c) Behavior of dry masonry blocks and structures under dynamic loading; (d) Possibilities of numerical analysis at the laboratory and engineering levels; (e) Monastery of Jerónimos as a case study: An EC funded research project aiming at reducing seismic vulnerability of CHB.

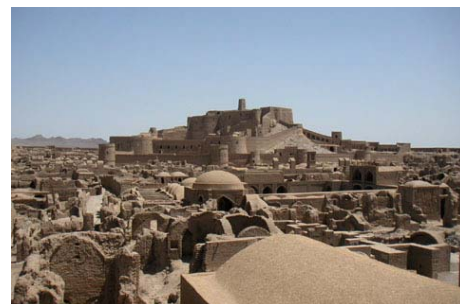
Figure 1. Historical citadel of Arg-e-Bam and the earthquake of December 2003: (a) before and (b) after.

Being earthquakes a major source of destruction of cultural heritage buildings, see Figure 1, this paper focus on recent advances and aspects under investigation at University of Minho.

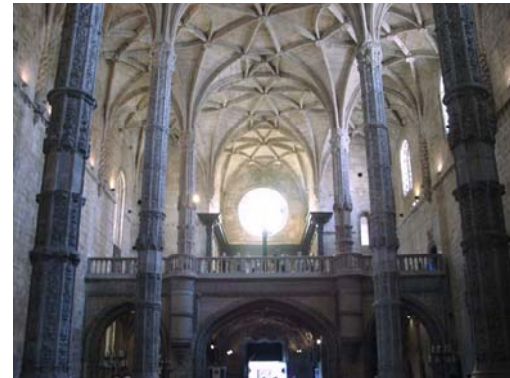
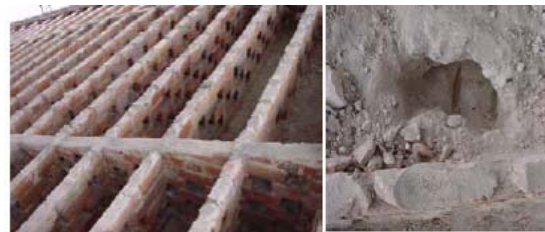
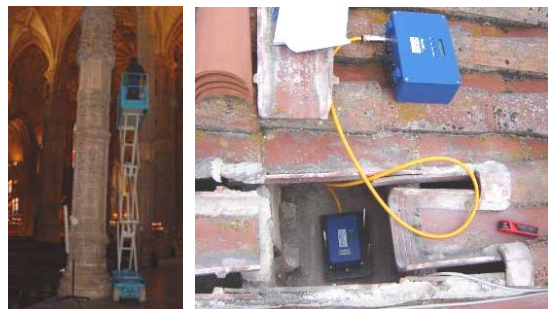
Figure 16. Monastery of Jerónimos: (a) view of the nave and choir (b) inspection of the vault nave; (c) survey of the columns; (d) radar inspection and ambient vibration acquisition.

Examples of the works already carried in this case study are shown in Figure 16 and Figure 17. This includes historic and geometrical survey, condition survey, a combination of non-destructive testing techniques, advanced simulation using non-linear finite elements and installation of remote controlled long-term static and dynamic monitoring systems.
